San Ignacio Heights Street Maintenance Plan

A Roadmap Forward to Uniform Pavement Maintenance

January 2023

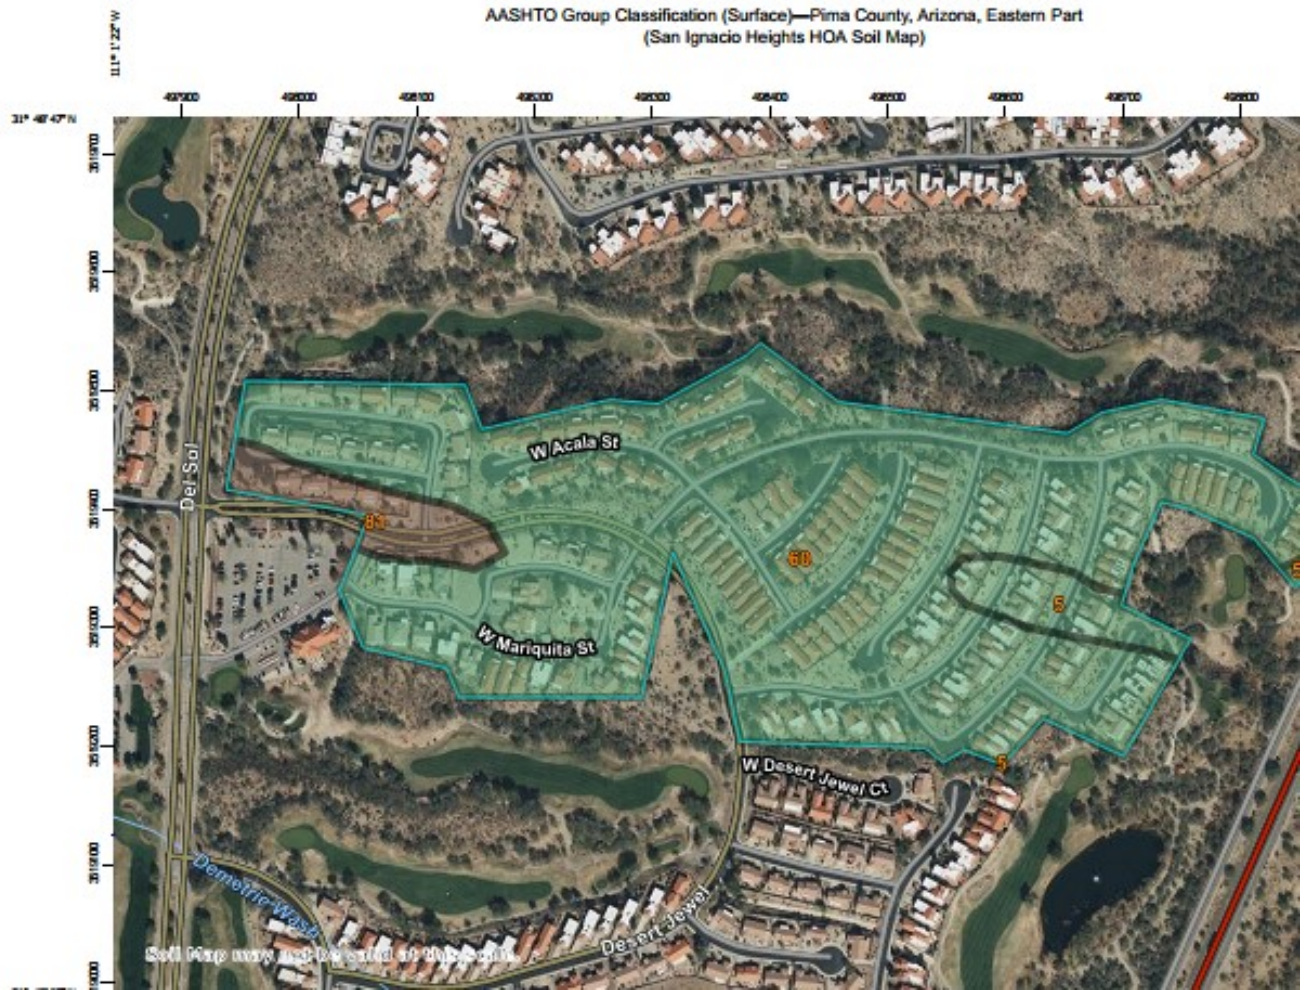
San Ignacio Heights HOA Soil Map

AASHTO Group Classification (Surface)—Pima County, Arizona, Eastern Part

The soils in the SIH HOA are an excellent road base. This is a main reason why our streets held up so well. They are a great mix of cobble, gravel, sand, silt and clay that is further cemented in areas with CaCO_3 (lime) the same stuff used in concrete. The ratings on the USDA Soil Survey 5/ show that you can drive heavy military vehicles on them with little effect. The majority (47 acres) of the soils in the approximately 50 acre area delineated in the map below have an American Association of State Highway and Transportation Officials (AASHTO) rating of A-1 (excellent) for subgrade.
